# Alkali-Silica Reactivity in the State of Montana

Presented By: Michael Berry

Funded By: MDT & MCA

Fall 2021

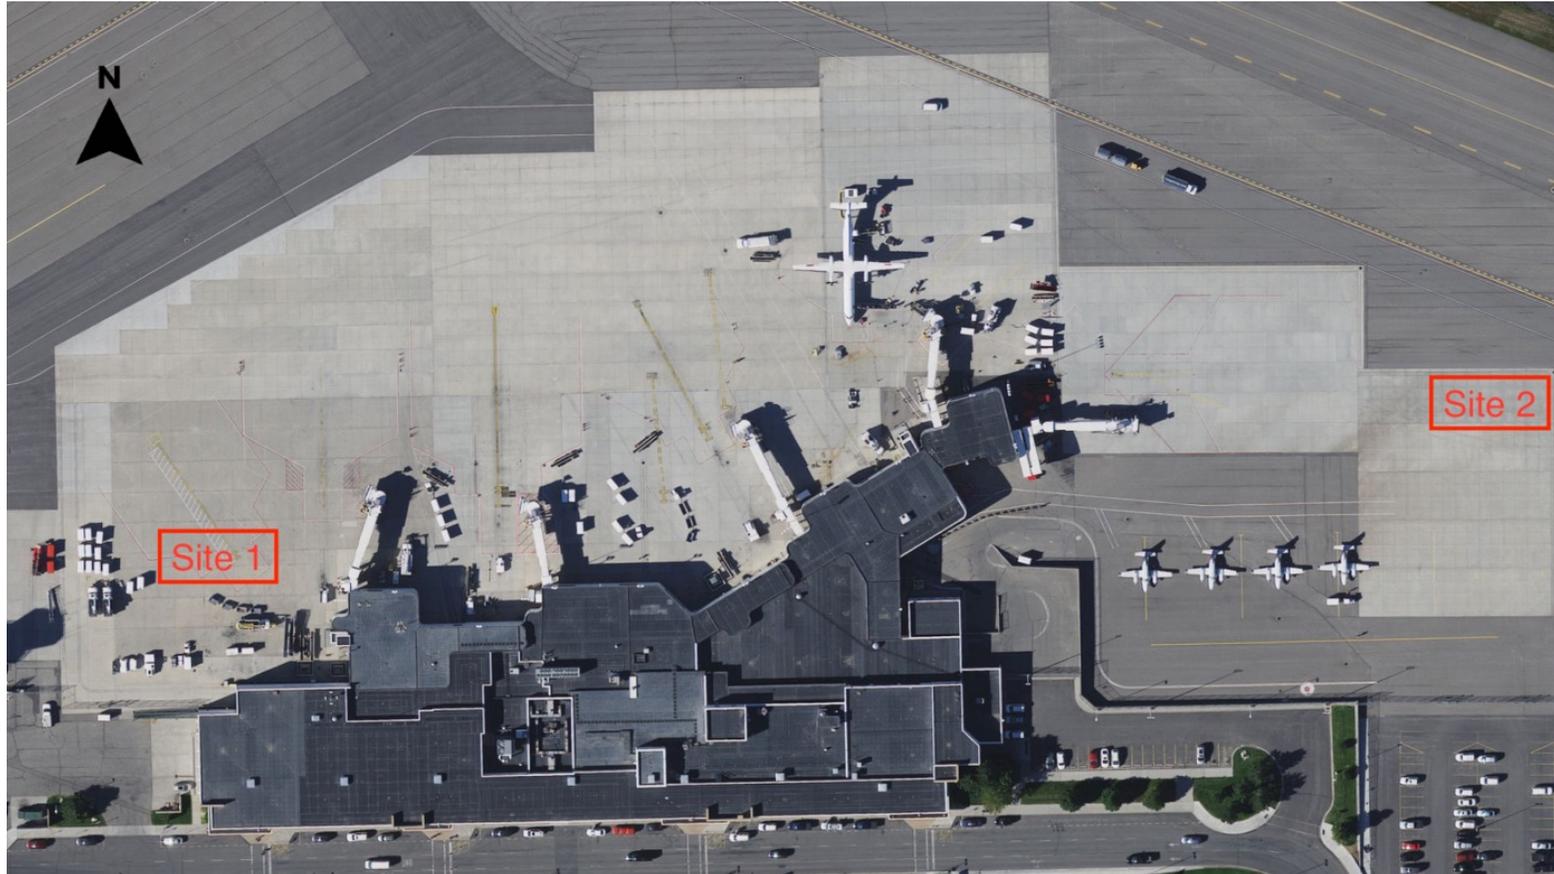
# Billings Logan International Airport

- Original construction - 40 years ago
- Paste comprised solely of hydrated portland cement
- Aggregate - crushed siliceous gravel - (1 in.)
  - Rhyolite, granite rocks, quartzite and chert
  - Trace amounts of andesite and basalt
- Located near terminal
- Approximate dimensions
  - 4" Diameter
  - 6 1/4" - 8" Length

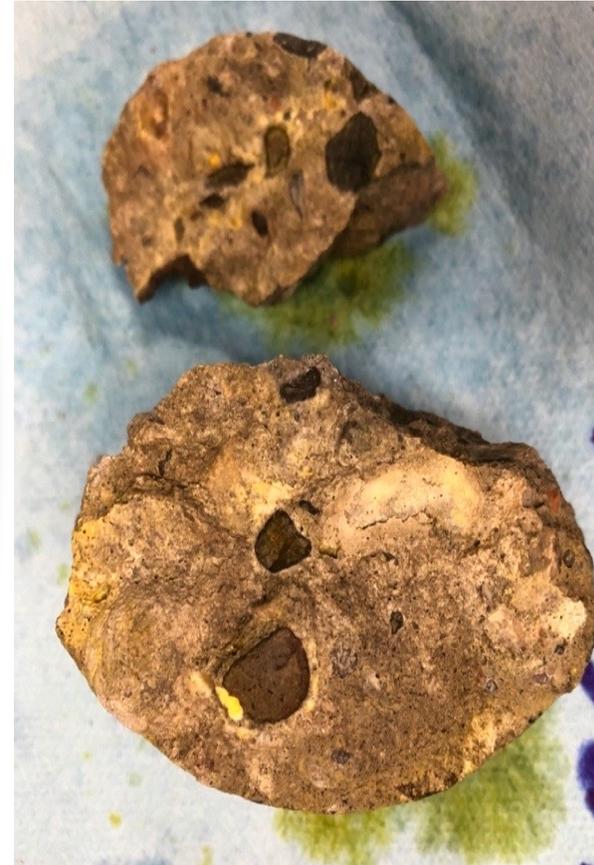
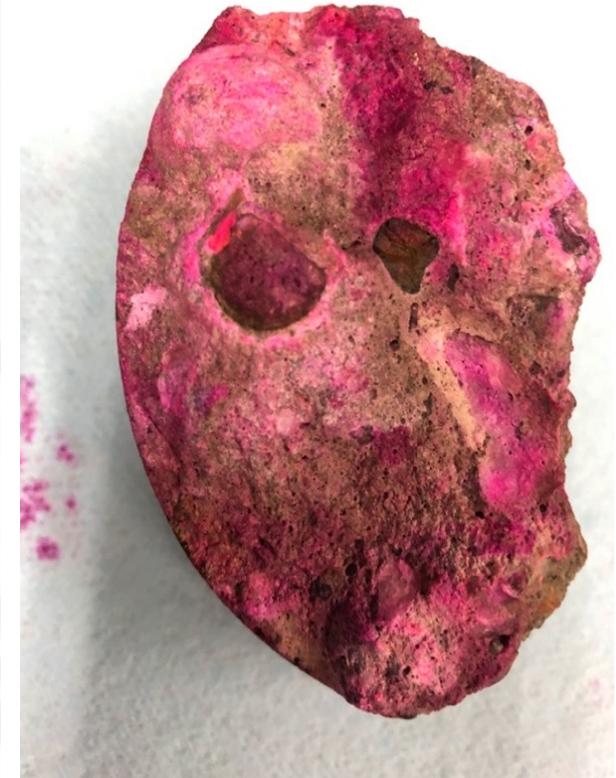
# Los Alamos Staining Method - Site 1

- Procedure
  - Apply distilled water to freshly broken surface
  - Apply yellow reagent to test surface
  - Wash off reagent with distilled water spray
  - Dry surface and examine for presence of ASR gel
  - Repeat process using red reagent
- Highly subjective results

- Billings Logan International Airport
  - The Los Alamos Staining results positive for ASR
  - ASR classified as severe/Type V in both sites
- Willow Creek Dam Spillway
  - Advanced ASR was detected in the ogee
- Belt Creek Bridge
  - Moderate to Severe/Stage IV ASR damage
- Demonstrated that cases of ASR in Montana do exist, and that the infrastructure in the state is susceptible to ASR

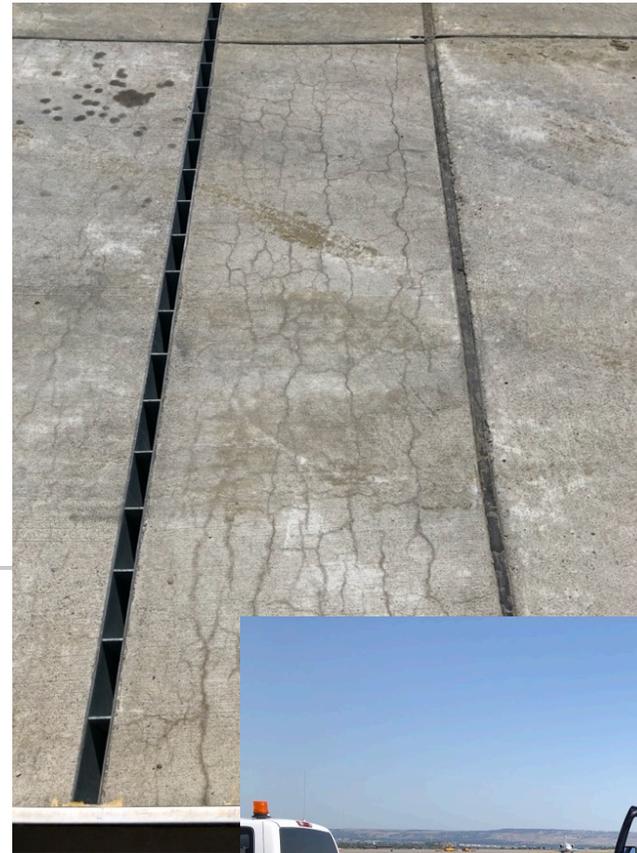
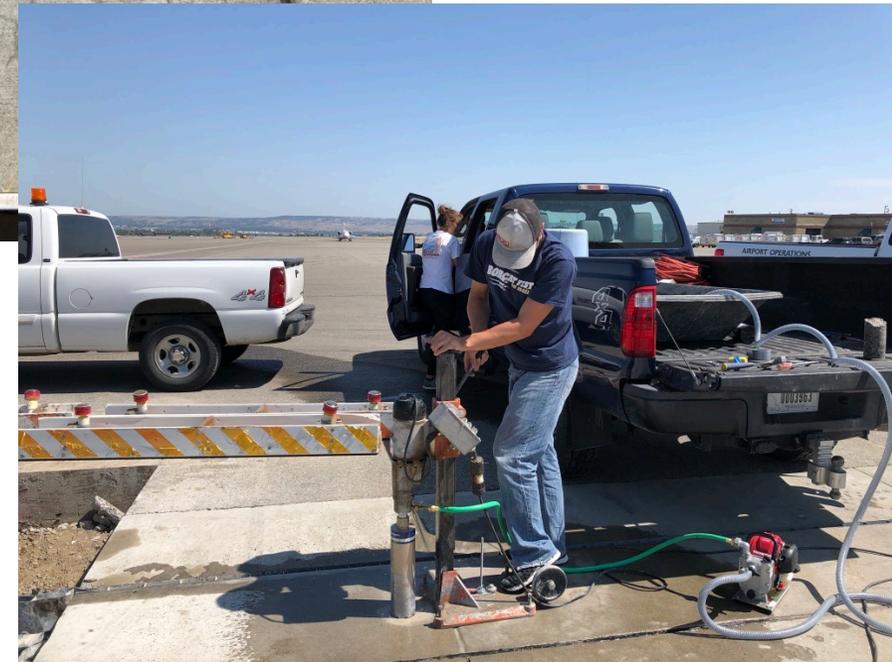
# Billings Logan International Airport - Site 2

- Original construction - 20 years ago
- Paste comprised of hydrated portland cement & fly ash
- Aggregate - crushed siliceous gravel - (3/4 in.)
  - Rhyolite, granite rocks, quartzite and chert
  - Trace amounts of andesite and basalt
- Located near drain
- Approximate dimensions
  - 4" Diameter
  - 6 1/4" - 8" Length

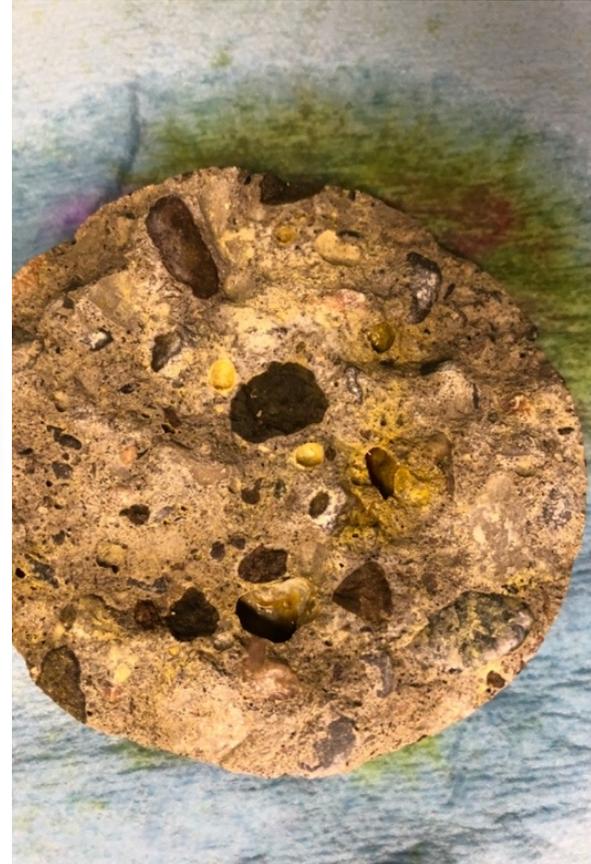
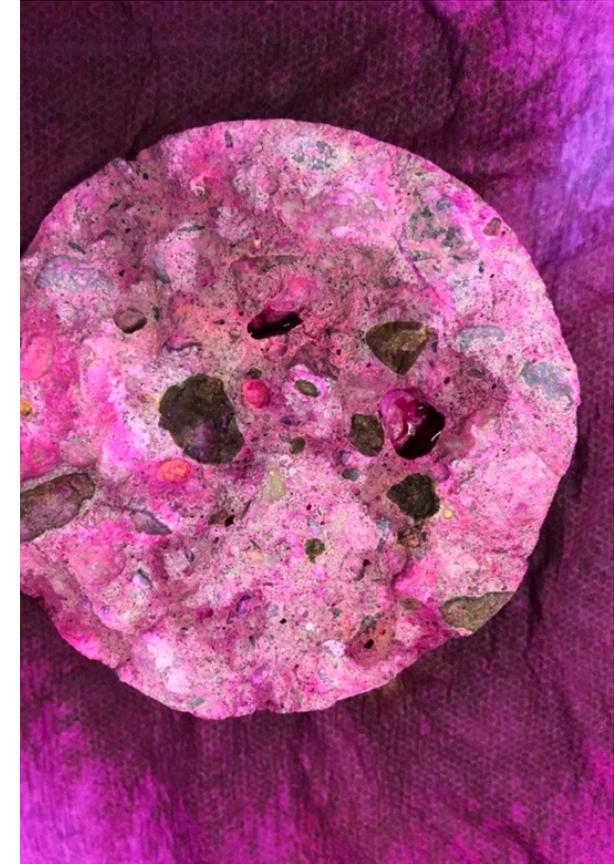
# Los Alamos Staining Method - Site 2

- Procedure
  - Apply distilled water to freshly broken surface
  - Apply yellow reagent to test surface
  - Wash off reagent with distilled water spray
  - Dry surface and examine for presence of ASR gel
  - Repeat process using red reagent
- Highly subjective results

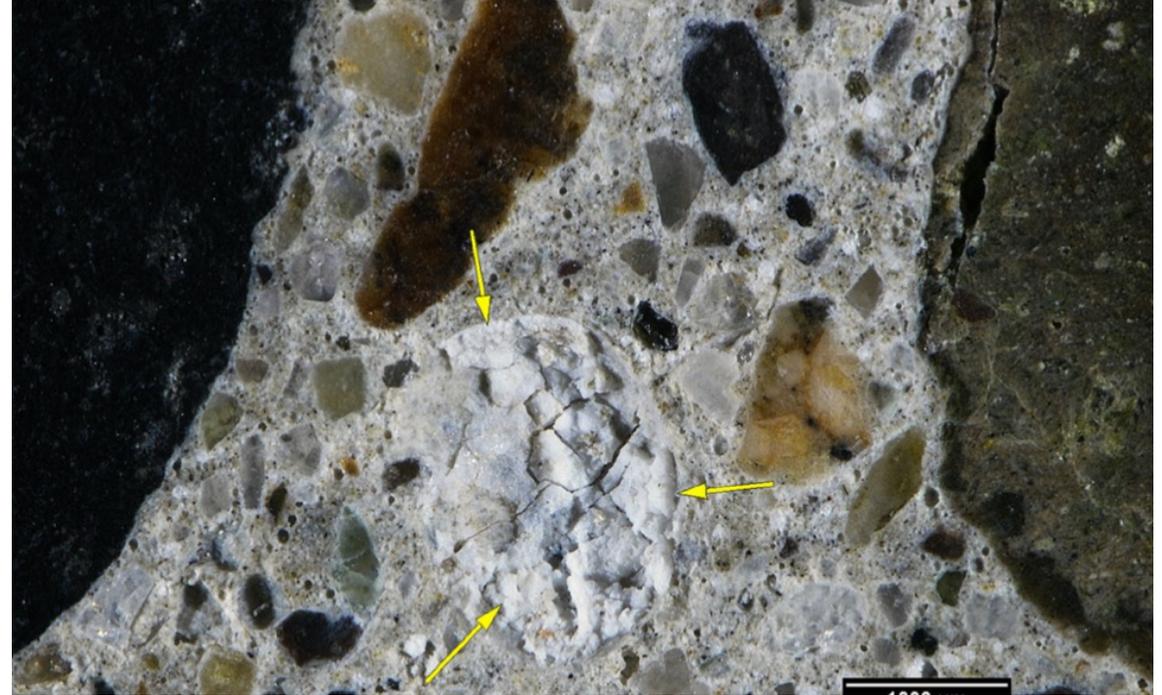
## Petrographic Analysis - Site 2

- Petrographic analysis per ASTM C856
- Concrete composition
  - No slag cement or other supplementary cementitious materials
  - Coarse and fine aggregate were of similar reactive constitution
- Failure mechanisms
  - Early age shrinkage cracking
  - Sub-horizontal cracking
  - Cracking and microcracking due to ASR
- ASR classified as "Severe / Type V"

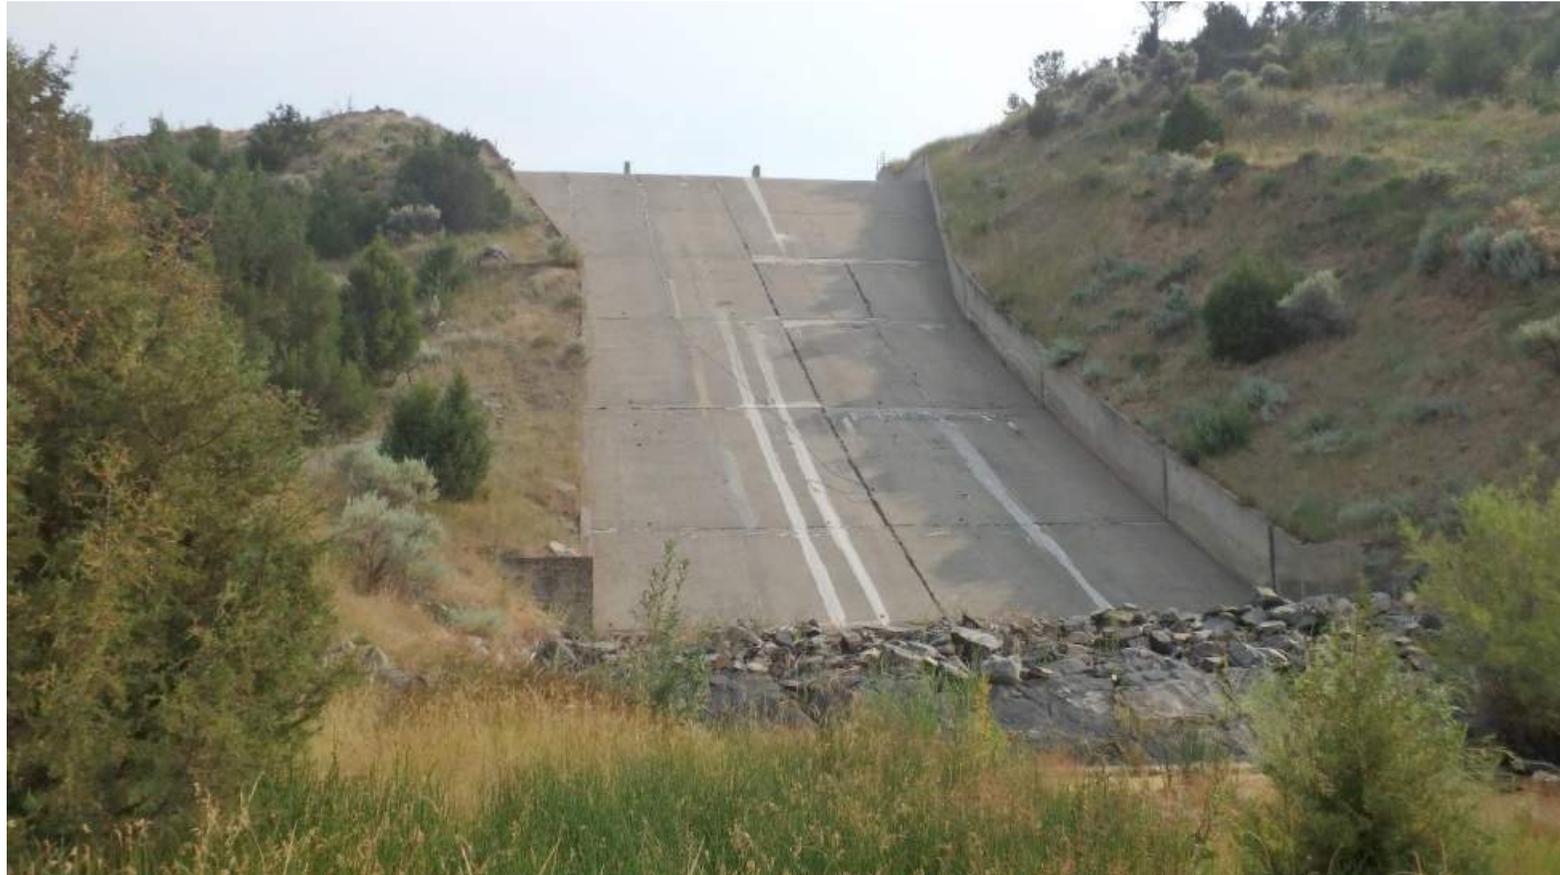
# Willow Creek Dam Spillway

- Original construction - 75 years ago
- Consists of:
  - Side walls, chute, flip bucket, ogee
- Minor repairs and sealant work completed
- WJE retained by DNRC to assess condition
- Paste comprised of portland cement
- Aggregate - natural siliceous gravel - (1 in.)
  - Felsic igneous and metamorphic rocks, quartzite, chert and sandstone
  - Trace amounts of carbonate.

- Petrographic analysis per ASTM C856
- Failure mechanisms
  - Transverse and longitudinal cracking
  - Patterned cracking
  - Freeze thaw distress
  - Alkali-silica reaction
- Advanced ASR was detected in the ogee
- Other areas of the slab exhibited ASR-related distress to a lesser extent.

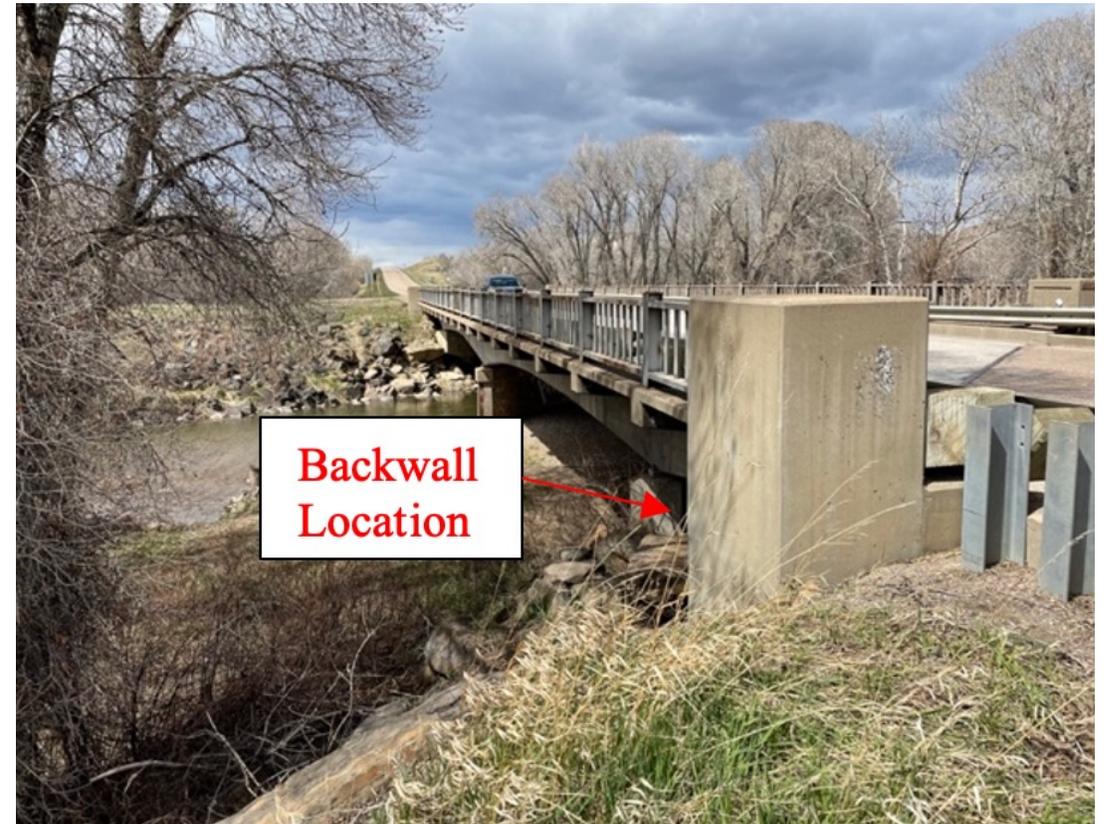
# US-87/US-89/MT 200 Bridge over Belt Creek

- Original construction - 1954
- Significant cracking/efflorescence observed on backwall
- 3 cores were extracted and sent to DRP for petrographic analysis
- Paste contains portland cement, no fly ash
- Aggregate - natural siliceous and carbonate rock
  - limestone, siliceous limestone, quartzite, chert, and siliceous volcanic rocks

- Petrographic analysis per ASTM C856
- Concrete composition
  - No slag cement or other supplementary cementitious materials
  - Coarse and fine aggregate were of similar reactive constitution
- Moderate to severe damage from ASR  
DRP Scale
- ASR classified as “Stage IV” Katayama  
Scale

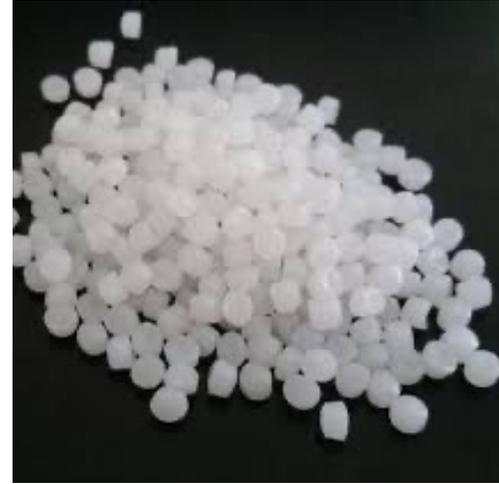
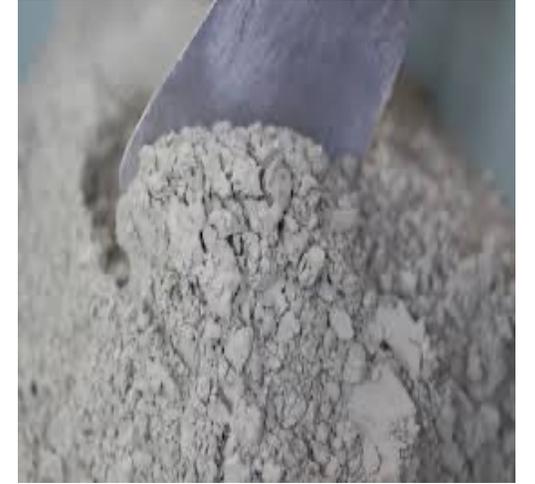
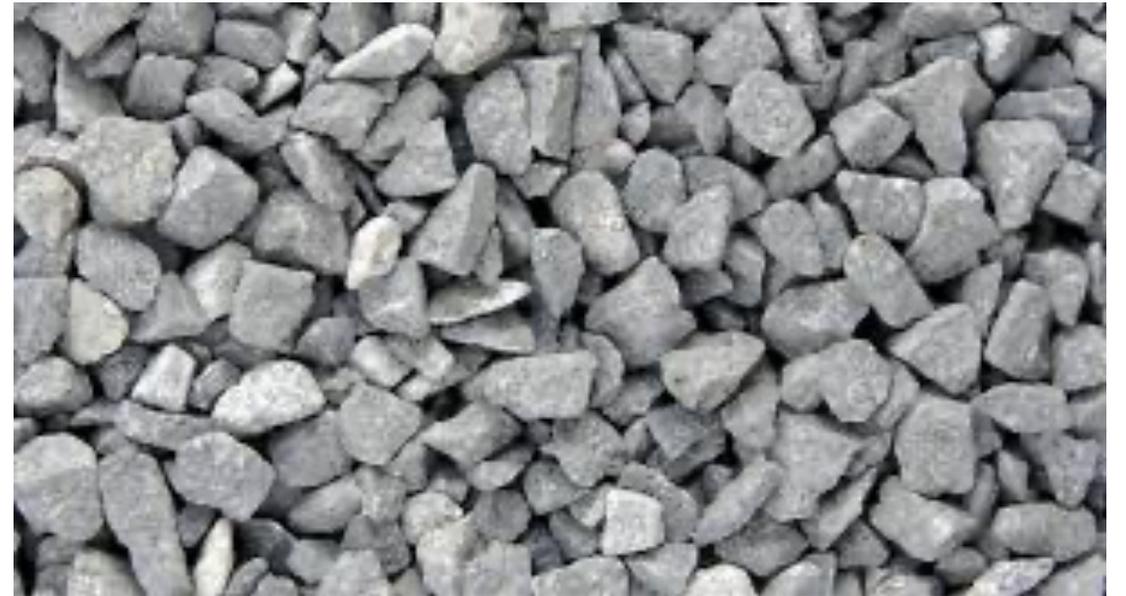
- Physical property tests per ASTM
  - Oven-dried specific gravity
  - Absorption
- Crush, sieve and recombine
- Mix proportions

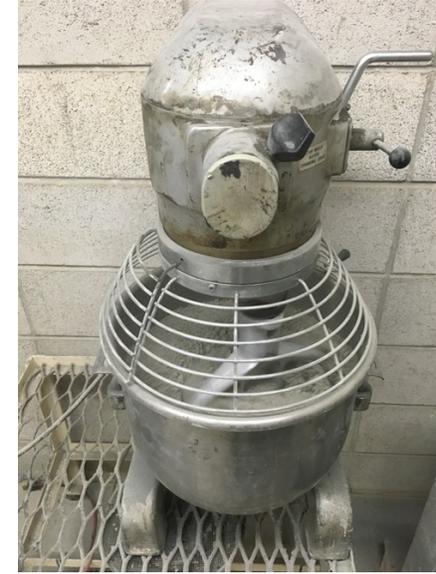
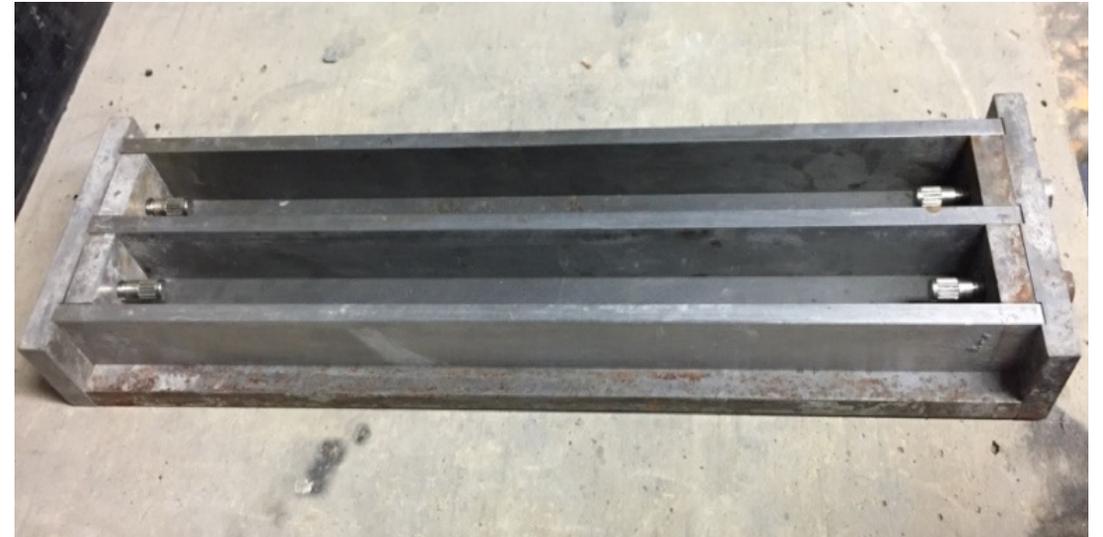
# Mixing - ASTM C1260

- Mixing per ASTM C305
- Three specimens per mix design
- Molds
  - 1 in. x 1 in. x 11.25 in. (25 mm x 25 mm x 285 mm)
  - Metal gauge studs
- Curing
  - Moist room - 24 hours
  - Demolded & initial reading
  - Water bath 80°C (176°F) - 24 hours

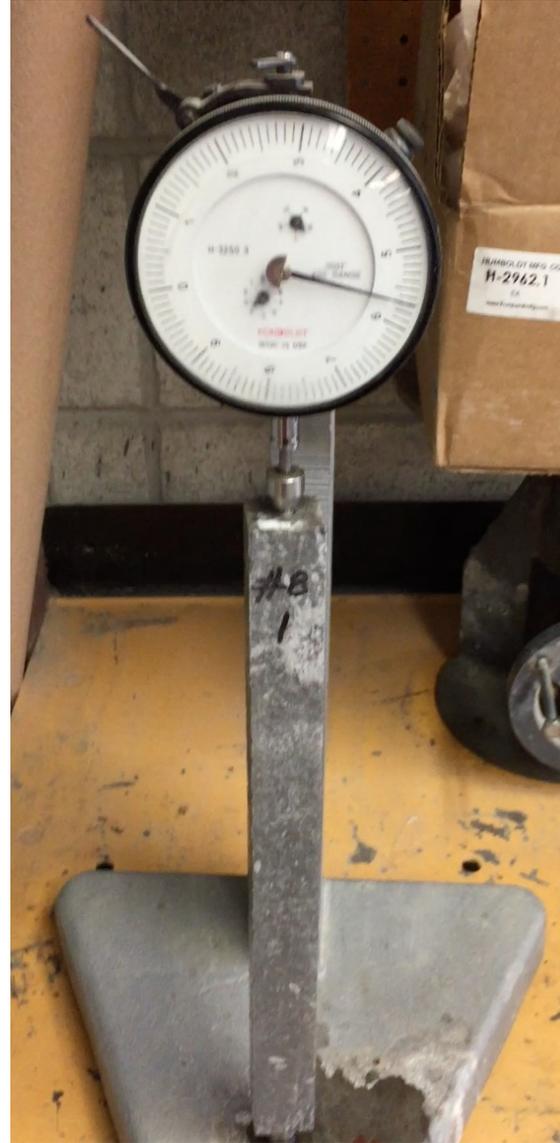
# Testing - ASTM C1260

- Storage
  - Approved Humboldt container
  - 1N NaOH solution at 80°C (176°F)
- Testing apparatus
  - Length comparator
  - Reference bar
- Testing period
  - Initial reading after demolding
  - Zero reading after water bath
  - 1, 3, 7, 10 and 14 days

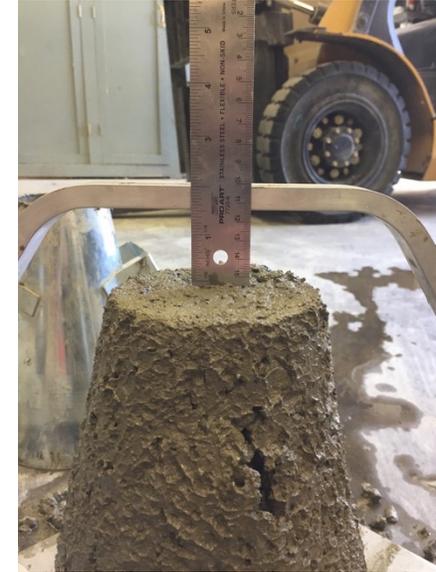
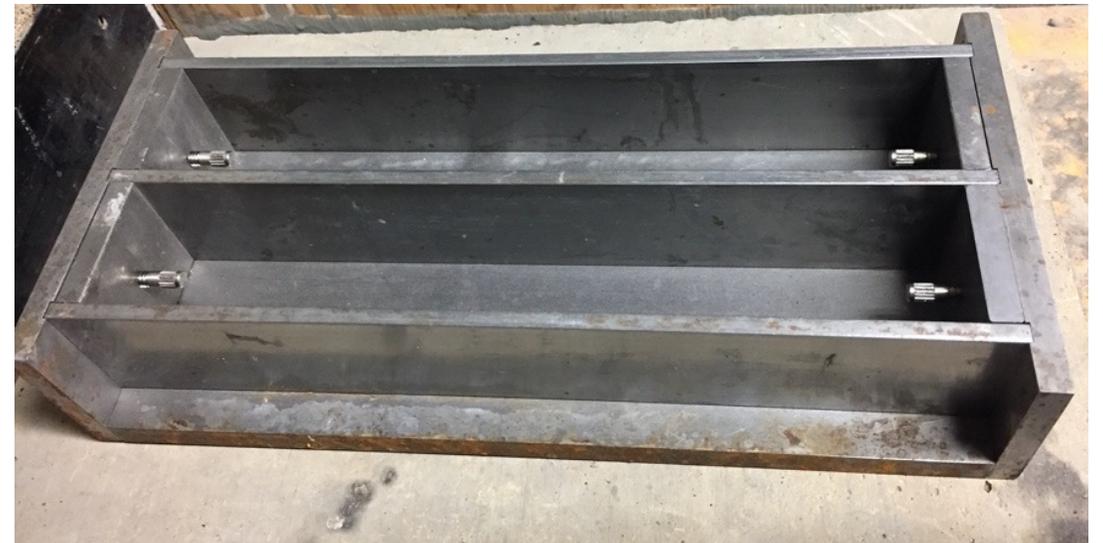
# Mixing - AASHTO T380

- Mixing per ASTM C192
- Three specimens per mix design
- Slump test
- Molds
  - 2 in. x 2 in. x 11.25 in. (50 mm x 50 mm x 285 mm)
  - Metal gauge studs
- Curing
  - Moist room - 24 hours
  - Demolded & initial reading
  - Water bath 60°C (140°F) - 24 hours

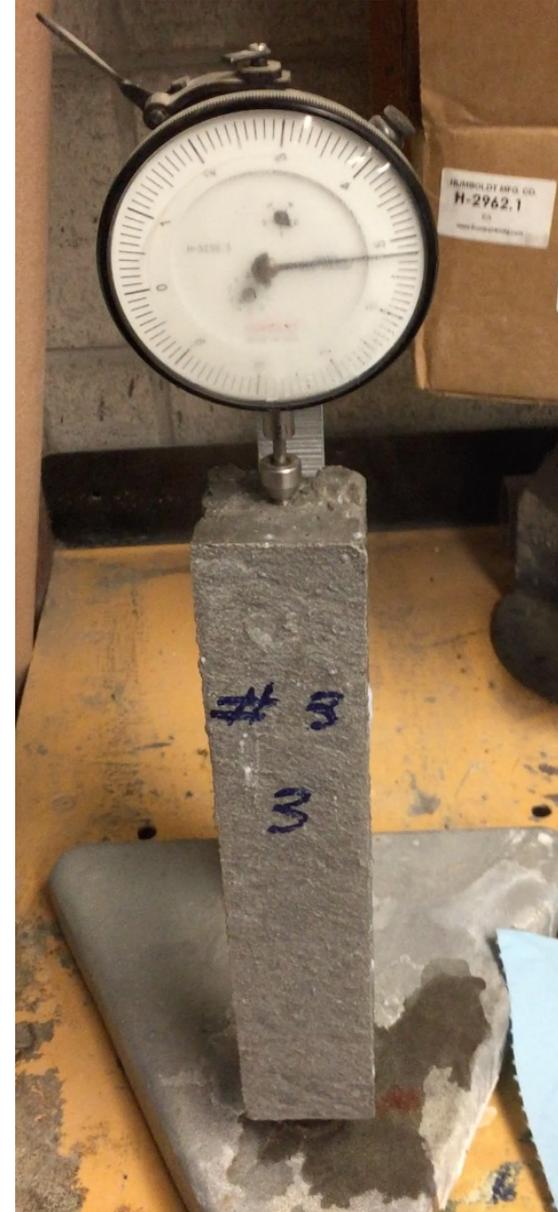
# Testing - AASHTO T380

- Storage
  - Approved Humboldt container
  - 1N NaOH solution at 60°C (140°F)
- Testing apparatus
  - Length comparator
  - Reference bar
- Testing period
  - Initial reading after demolding
  - Zero reading after water bath
  - 1, 3, 7, 10, 14, 21, 28, 42 and 56 days
